Manhole Inspection Summary

Manhole # S47GG_046MH

Insp Date: **6/18/08 11:27 AM**

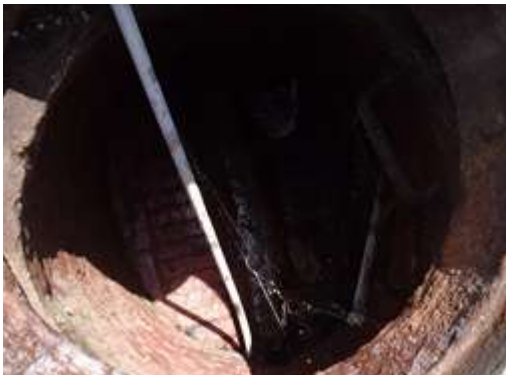
Defect 2

Infiltration: ☐ None ☐ Joint ☐ Cracks ☐ Mortar ☐ Roots ☒ **Wall**

infiltration

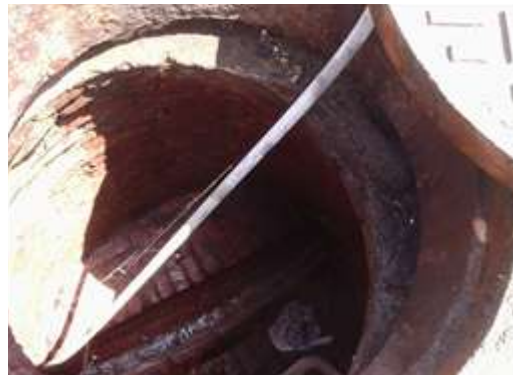
Defect 1

deterioration

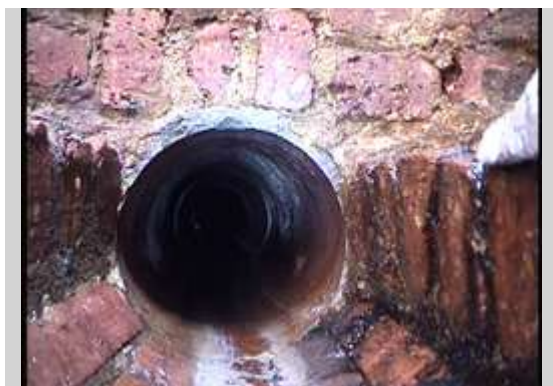
12 O'Clock Outflow

8 in. Circular Gravity Sewer
Pipe Out @ 12 O'Clock

Pipe Height: **8.4** (in.) Rod and Bar (Angled)
Pipe Material: **Clay** ☐ Pipe Lined
Invert Depth: **6.60** (ft.) Flow Characteristics: **Fast**
Deposits: ☒ None ☐ Mud ☐ Sludge ☐ Debris ☐ Grease
Silt Depth: (in.) Deposits Extent:
Infiltration: **None** Pipe Seal Cond: **Sound**

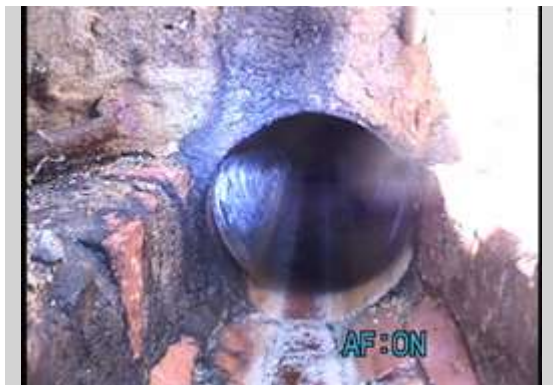
6 O'Clock Inflow

8 in. Circular Gravity Sewer
Pipe In @ 6 O'Clock

Pipe Height: **8.4** (in.) Rod and Bar (Angled)
Pipe Material: **Clay** ☐ Pipe Lined
Invert Depth: **6.20** (ft.) Flow Characteristics: **Fast**
Deposits: ☒ None ☐ Mud ☐ Sludge ☐ Debris ☐ Grease
Silt Depth: (in.) Deposits Extent:
Infiltration: **None** Pipe Seal Cond: **Sound**
